STREAM CROSSING DATA FORM

ROUTE: Access Rd btwn 109 & 100 DATE: 7/10/06

STREAM CROSSING DATA

CHANNEL ID	<u>ARIA13-ST1</u>		
NAME (or trib. to)	<u>—</u>		
TYPE OF STREAM			
PEREN/INTERMIT			
WIDTH (obser/ohw)	<u>N/A / 4'</u>		
DEPTH (obser/ohw)	<u>N/A / 1'</u>		
FLOW RATE ¹	<u>N/A</u>		
FLOW DIRECTION	<u>NE</u>		
SUBSTRATE	<u>Silt loam</u>		
BANK VEGETATION	<u>PEW</u>

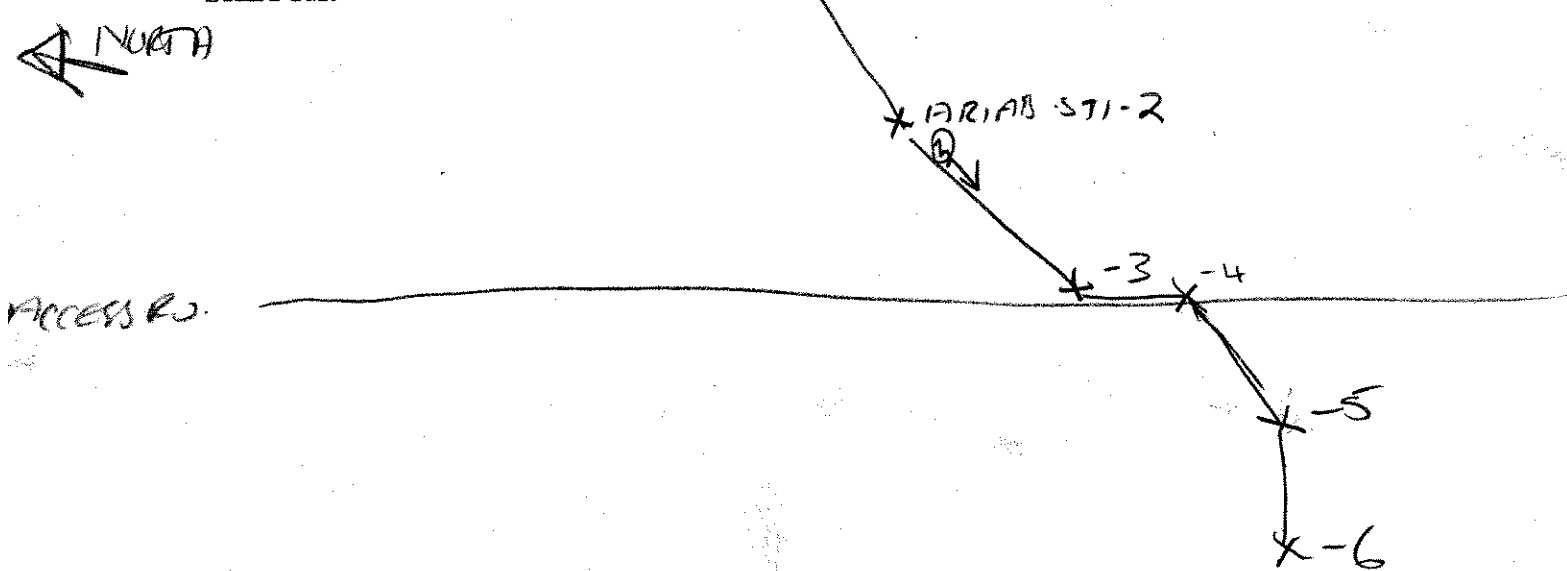
SKETCH:

Int stream Assoc. mud w/ wetland
ARIA13

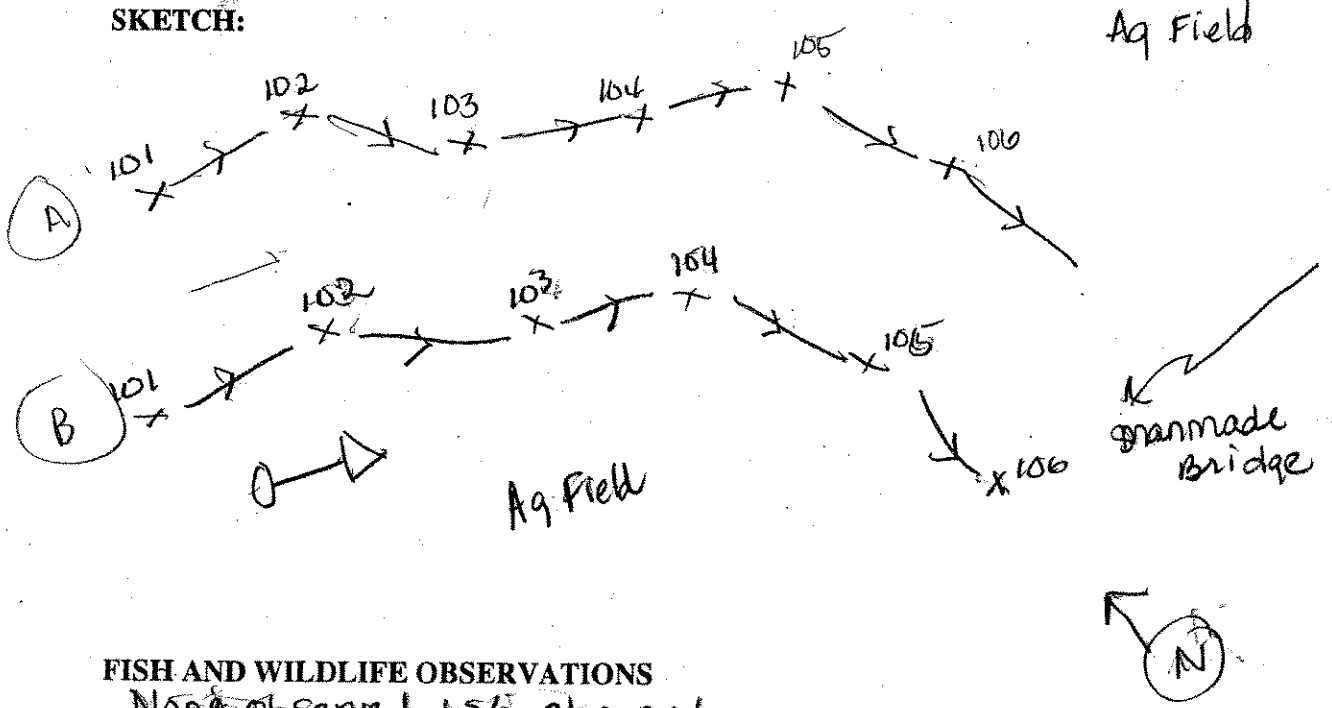
SKETCH:

CHANNEL ID	AR1-AB-ST	Vege (Bank)	Vege (Channel)
NAME (or trib. to)		<i>Spirea tomentorum</i>	<i>Caltha palustris</i>
TYPE OF STREAM		<i>Impatiens capensis</i>	<i>Impatiens capensis</i>
PEREN/INTERMIT	Intermitt ?	<i>Salix</i>	<i>Gallium</i>
WIDTH (obser/ohw)	4' / 8'	<i>Aster sp.</i>	
DEPTH (obser/ohw)	8" / 16-20"	<i>Populus</i>	
FLOW RATE ¹	Low	<i>Acer rubrum</i>	
FLOW DIRECTION	N, NE to E	<i>Taraxacum</i>	
SUBSTRATE	Silt + Cobble	<i>Gallium</i>	
BANK VEGETATION	PEM / SS

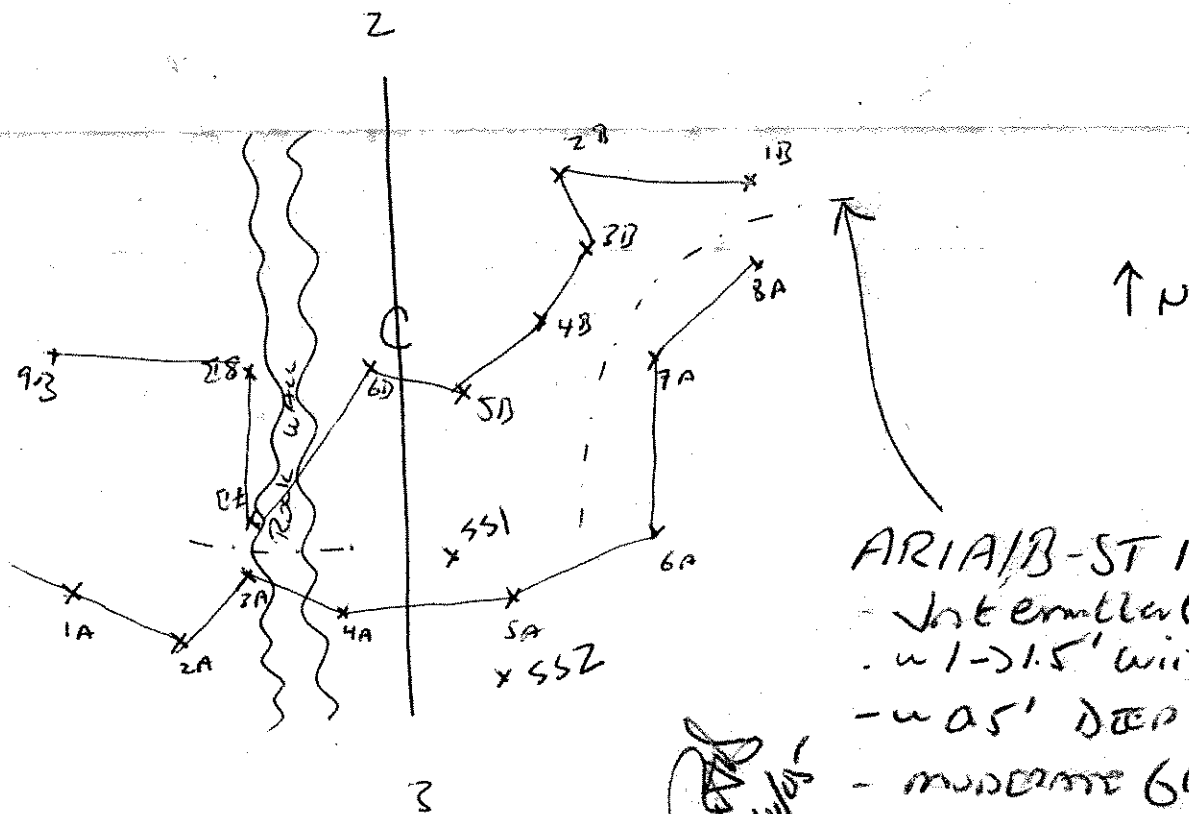
WETLAND ARI - A Line & B Line

- ARIA/B-ST 1
- Intermittent
 - w 1-2.5' wide
 - w 5' DEEP
 - moderate flow
 - silt substrate
 - flow to east

PSS / PEM

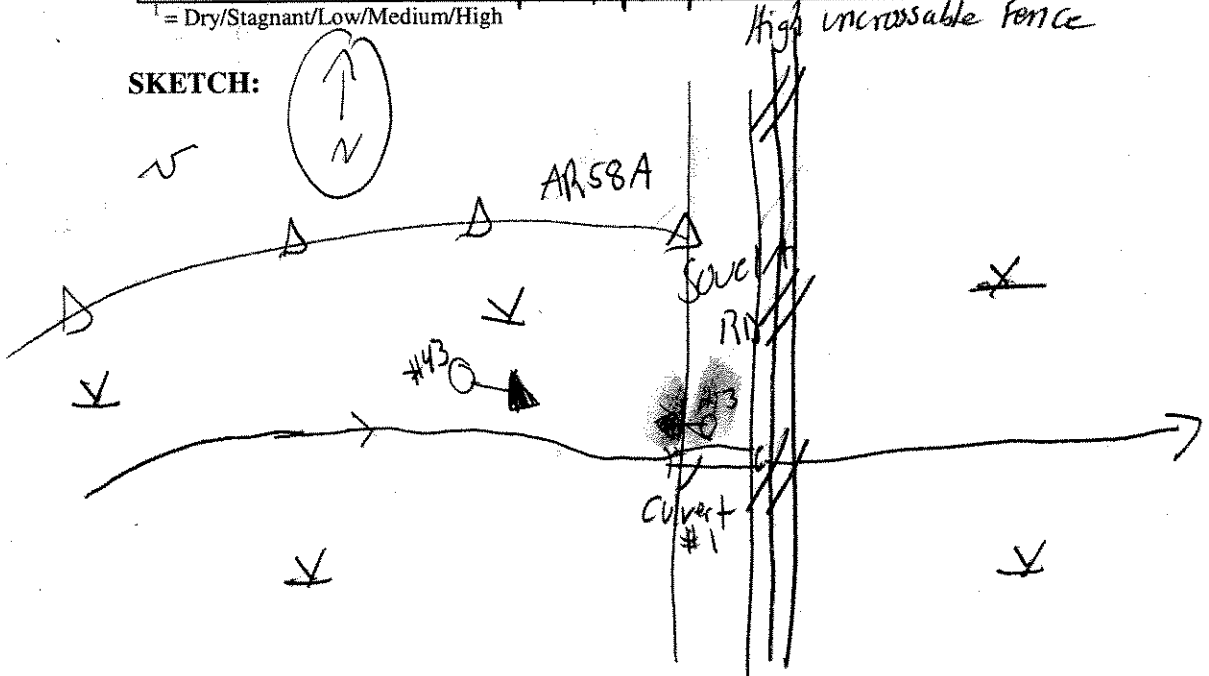
SKETCH:

CHANNEL ID	AR58A/BS#1/5		
NAME (or trib. to)	Unknown		
PEREN/INTERMIT	Intermittent		
WIDTH (obser/ohw)	3-5'		
DEPTH (obser/ohw)	>6"		
FLOW RATE ¹	Low		
FLOW DIRECTION	East		
SUBSTRATE	SAND/Gravel		
BANK VEGETATION	Flat top Aster, Sillily willow, prairie sp.

Heavy rains within last 24 hours - Intermittent streams
low flow

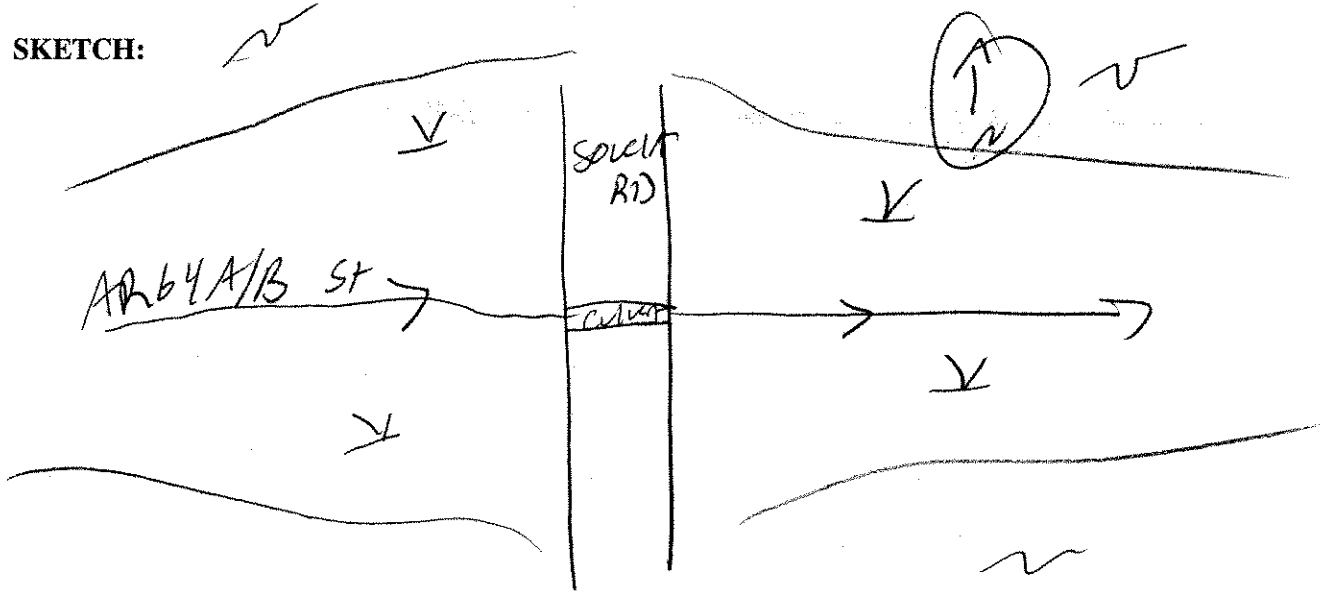
SKETCH:

CHANNEL ID	<u>AR64A/B-ST</u>		
NAME (or trib. to)	<u>unknown</u>		
PEREN/INTERMIT	<u>Interm.</u>		
WIDTH (obser/ohw)	<u>5-8'</u>		
DEPTH (obser/ohw)	<u>avg 6 inches</u>		
FLOW RATE ¹	<u>Low</u>		
FLOW DIRECTION	<u>East</u>		
SUBSTRATE	<u>Blay Muck</u>		
BANK VEGETATION	<u>Cumy Reed Grass</u>

recent rainfall in last 12 hours

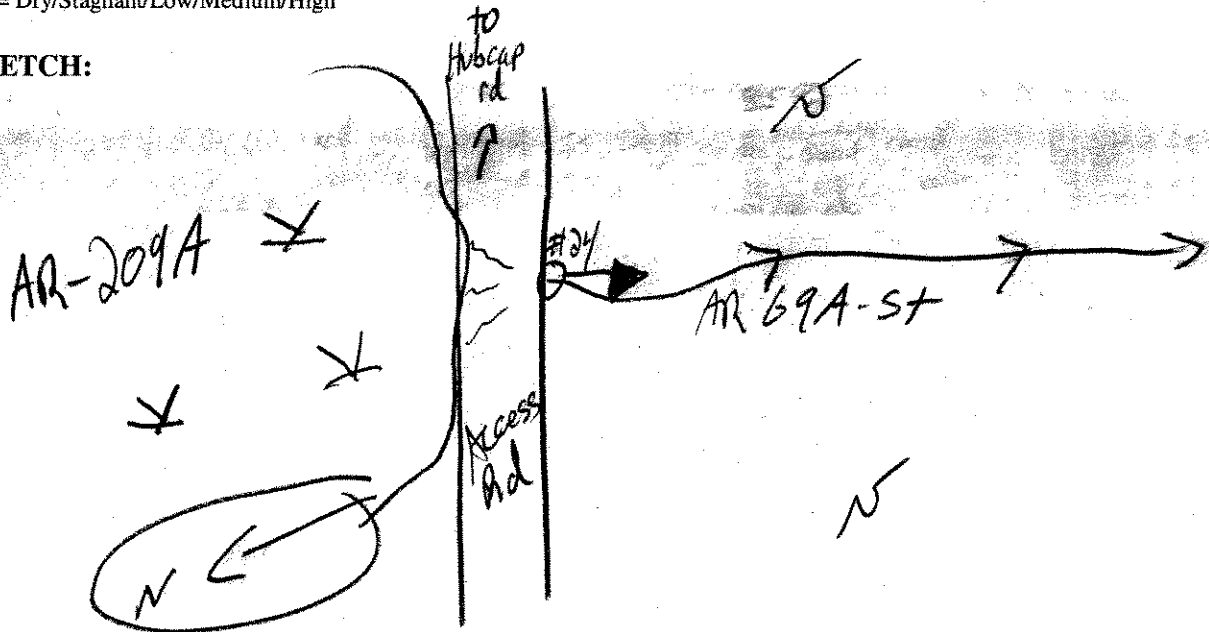
SKETCH:

CHANNEL ID	AR 69A-st1		
NAME (or trib. to)	unknown		
PEREN/INTERMIT	Peren		
WIDTH (obser/ohw)	2-3'		
DEPTH (obser/ohw)	5-6"		
FLOW RATE ¹	stagnant		
FLOW DIRECTION	S/SW		
SUBSTRATE	Muck		
BANK VEGETATION	Poa sp, ^{salidag} _{canadensis}

AR209A
 - Draining under road from wetland N. of road
 - sulfidic odor

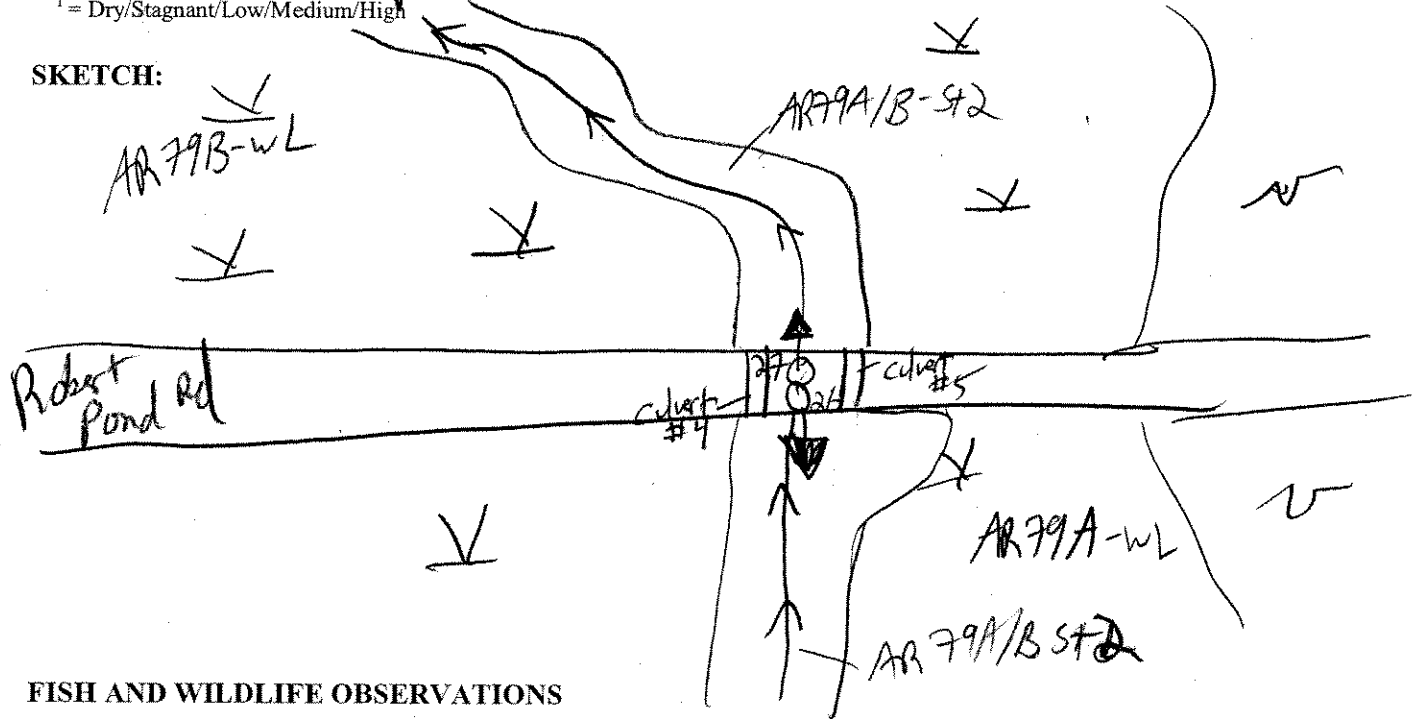
SKETCH:

CHANNEL ID	AR 79A/B-92		
NAME (or trib. to)	unknown		
PEREN/INTERMIT	Peren		
WIDTH (obser/ohw)	15-20'		
DEPTH (obser/ohw)	12-16"		
FLOW RATE ¹	Medium		
FLOW DIRECTION	S-N		
SUBSTRATE	Sand Gravel		
BANK VEGETATION	Speckled Alder

Raining during observation

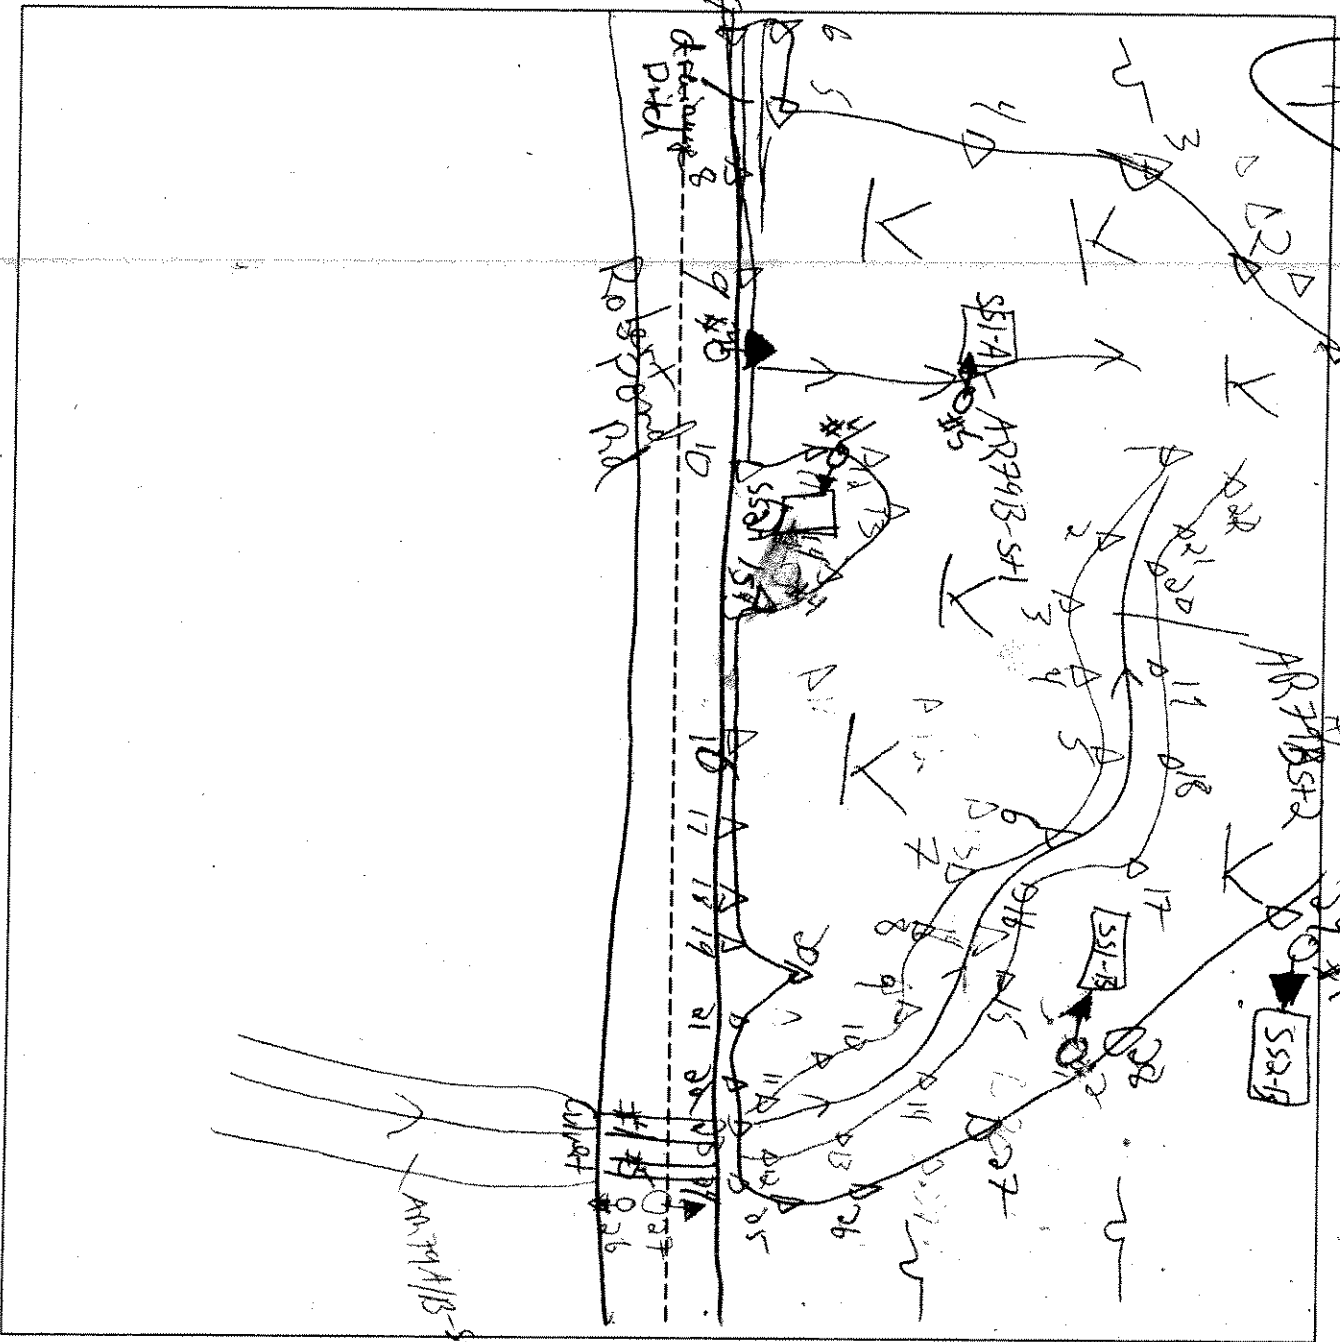
SKETCH FORM

Wetland ID/Route #: AR 79 B / AR 79 B-SH / AR 79 A/B-SH	Date: 10/23/05	Time: 15:00
Initials of Delineators: KHA, AK	Location: Clinton Co.	
Roll #: 5	Frames: 5, 4, 3, 2, 1	Roll # 27 N, 26 S

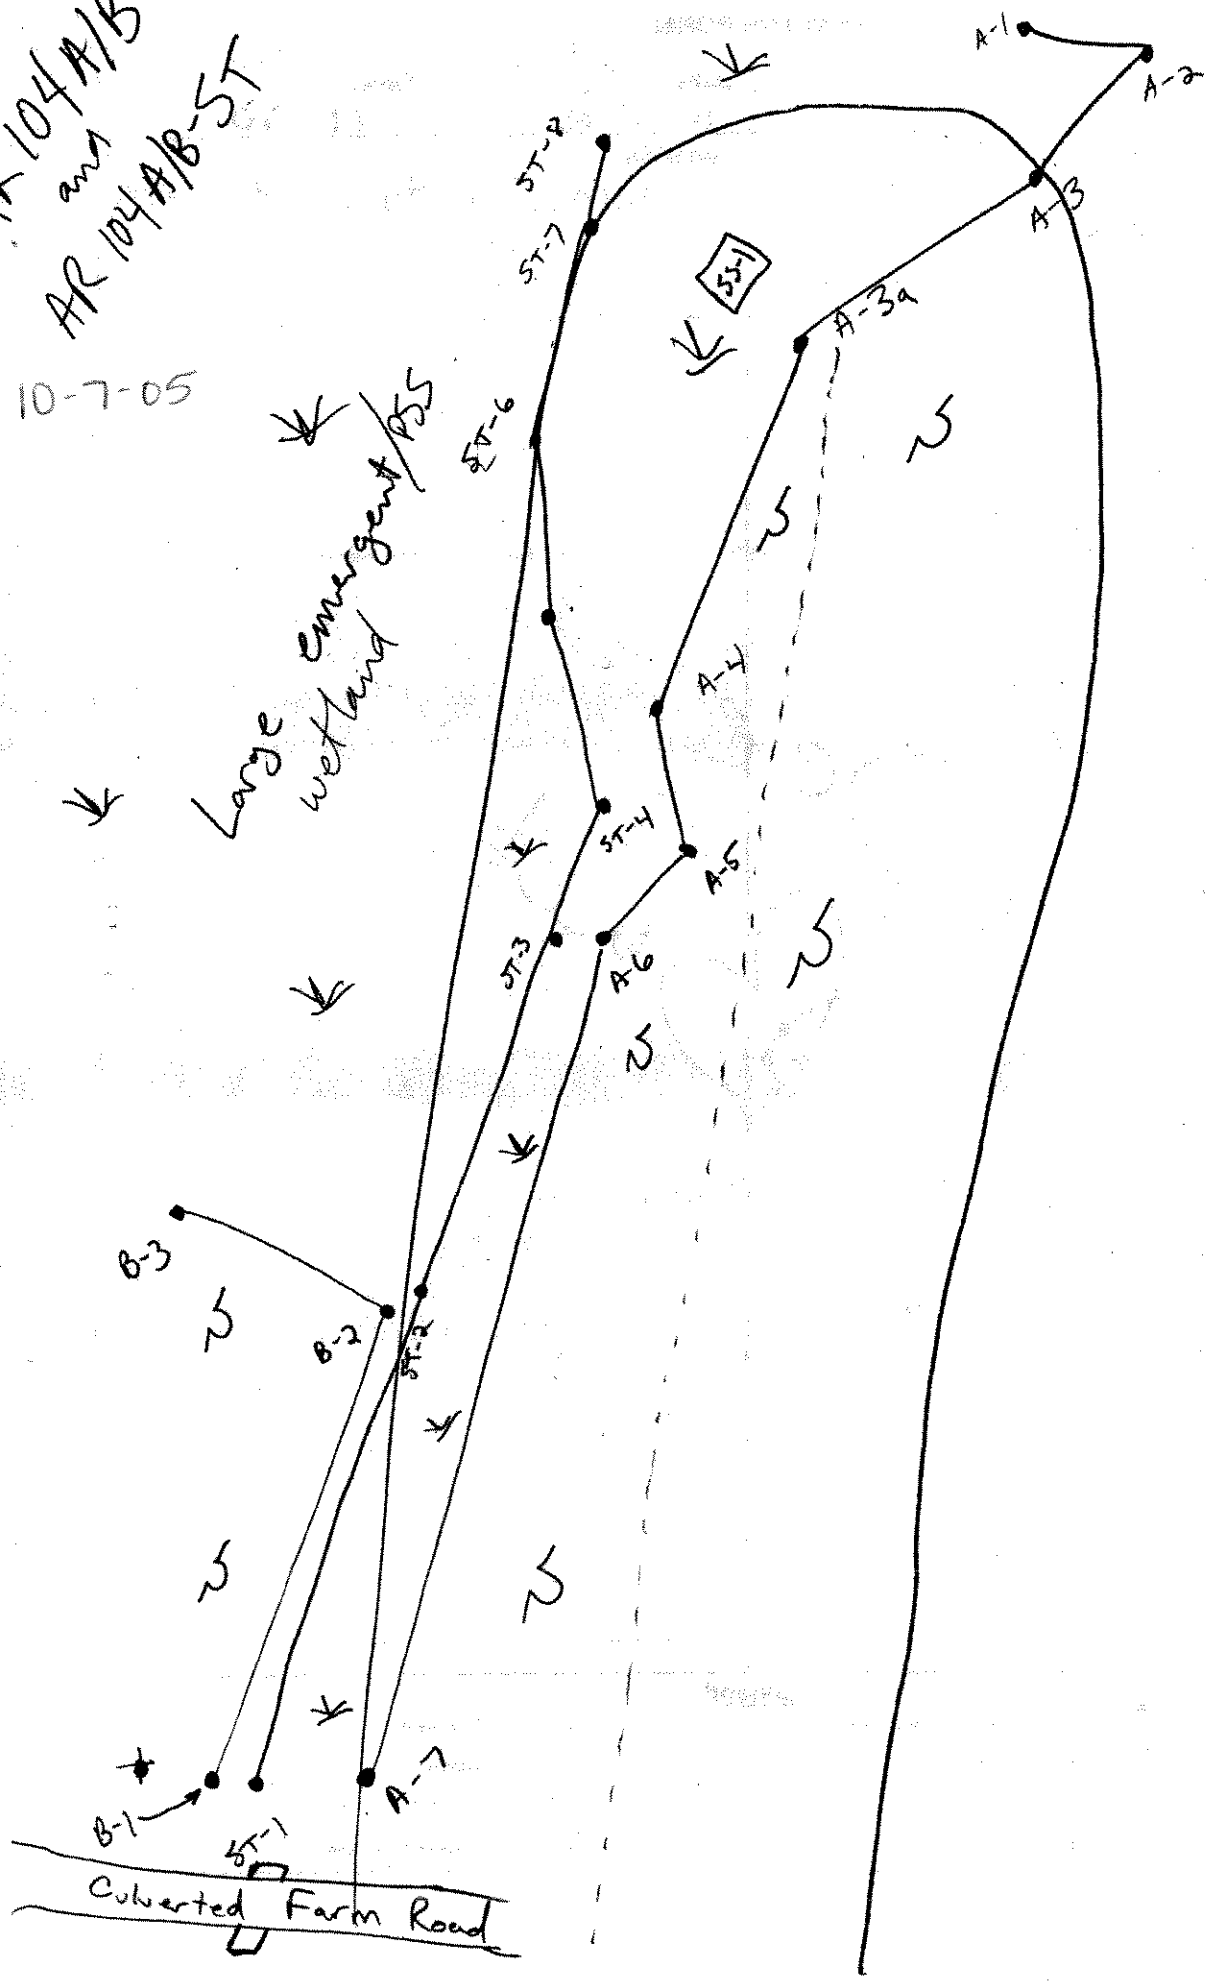
AR 104 A/B
AR 104 A/B-ST

Large emergent wetland / PSS

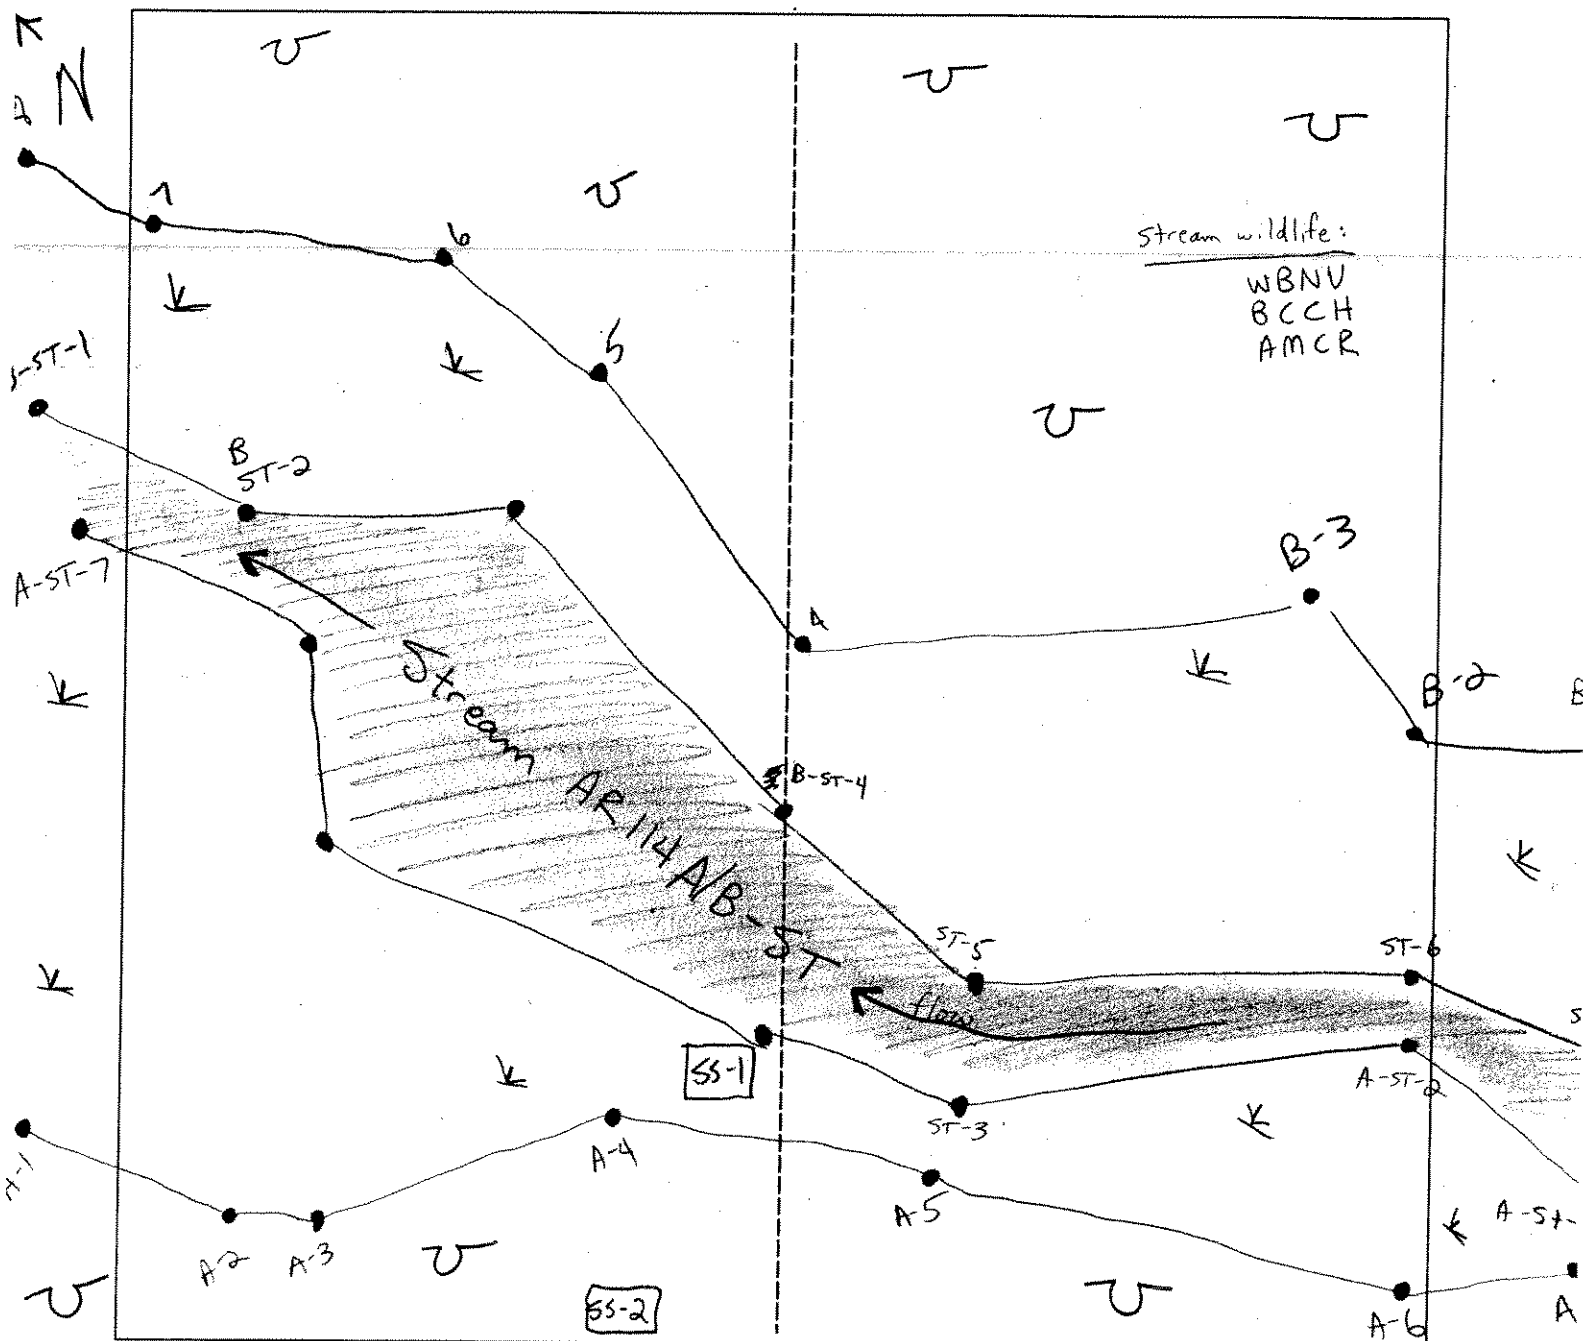
SKETCH FORM

Wetland ID/Route #: AR114 A/B with AR114 A/B-ST	Date: 10-10-05	Time: 12:30 pm
Intials of Delineators: S.R. J.A.	Location: Clinton County Wind Farm	
Roll #:	Frames:

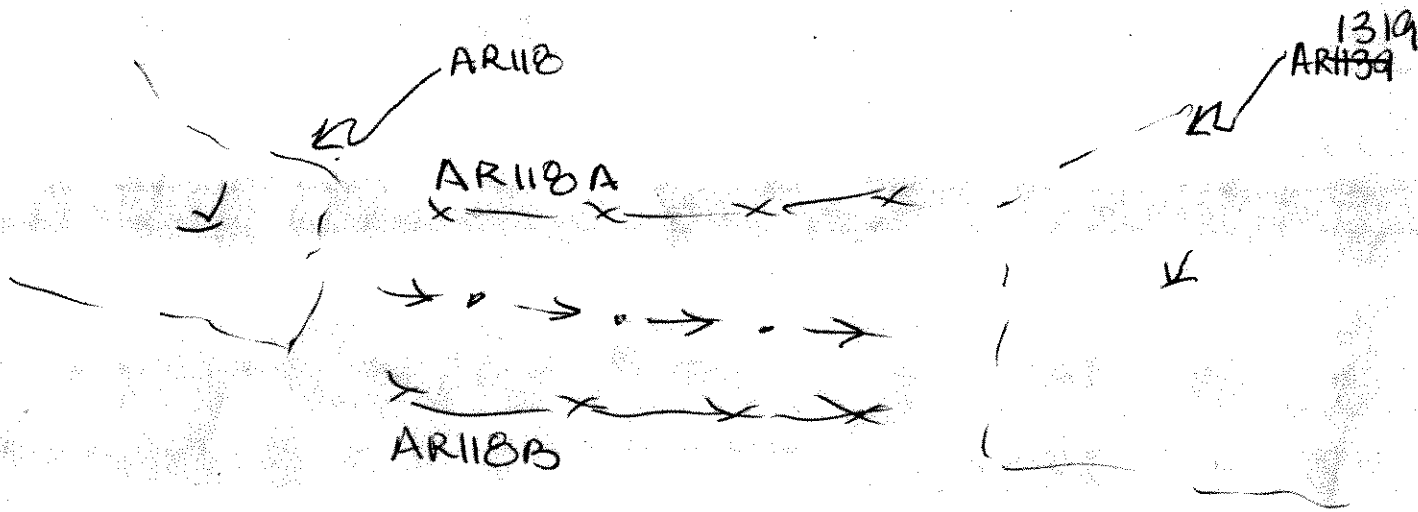
SKETCH:

CHANNEL ID	AR118 A/B ST		
NAME (or trib. to)	UNK		
TYPE OF STREAM	—		
PEREN/INTERMIT	Intermit		
WIDTH (obser/ohw)	12-50" / 20-48"		
DEPTH (obser/ohw)	NA / 36"		
FLOW RATE ¹	Dry		
FLOW DIRECTION	East		
SUBSTRATE	Gravel / Cobble		
BANK VEGETATION	Woody / Herbs

Intermit stream drains results from drainage from W at higher slope.

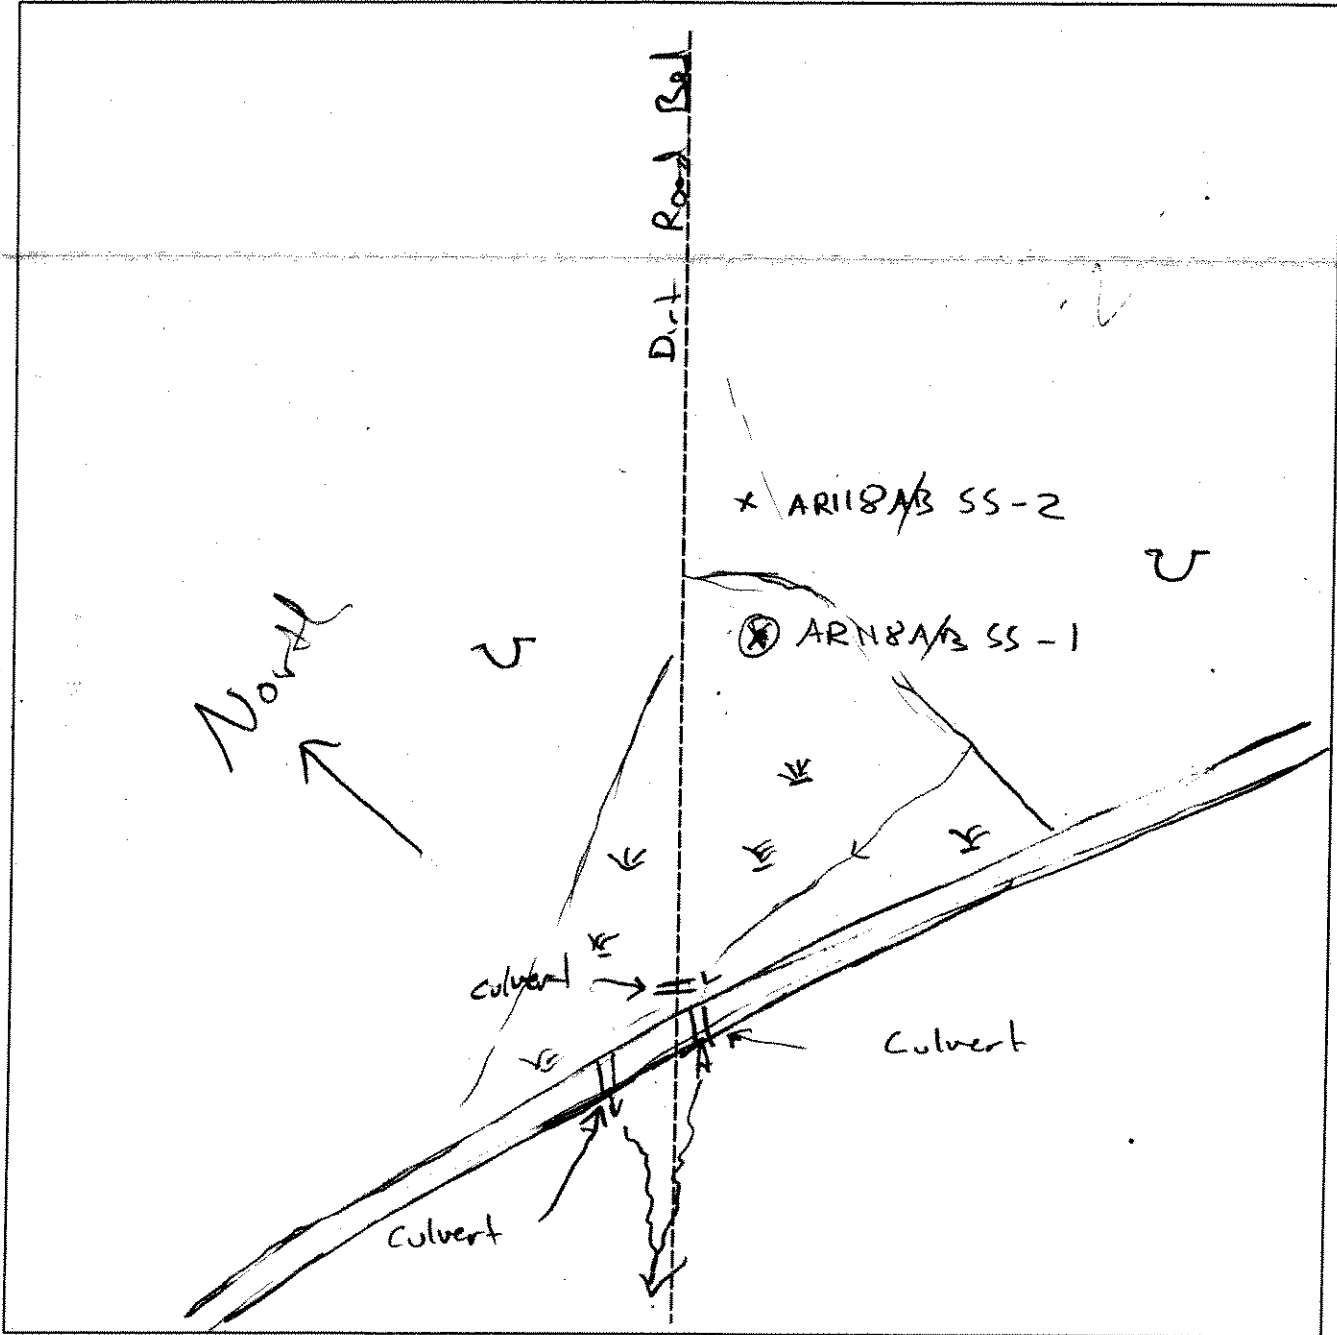
SKETCH FORM

Wetland ID/Route #: AR118AB	Date: 11 Oct 2005	Time: 1:00
Initials of Delineators: JA, JF, SR	Location: Clinton County Wind Farm	
Roll #: Photo to NE	Frames:

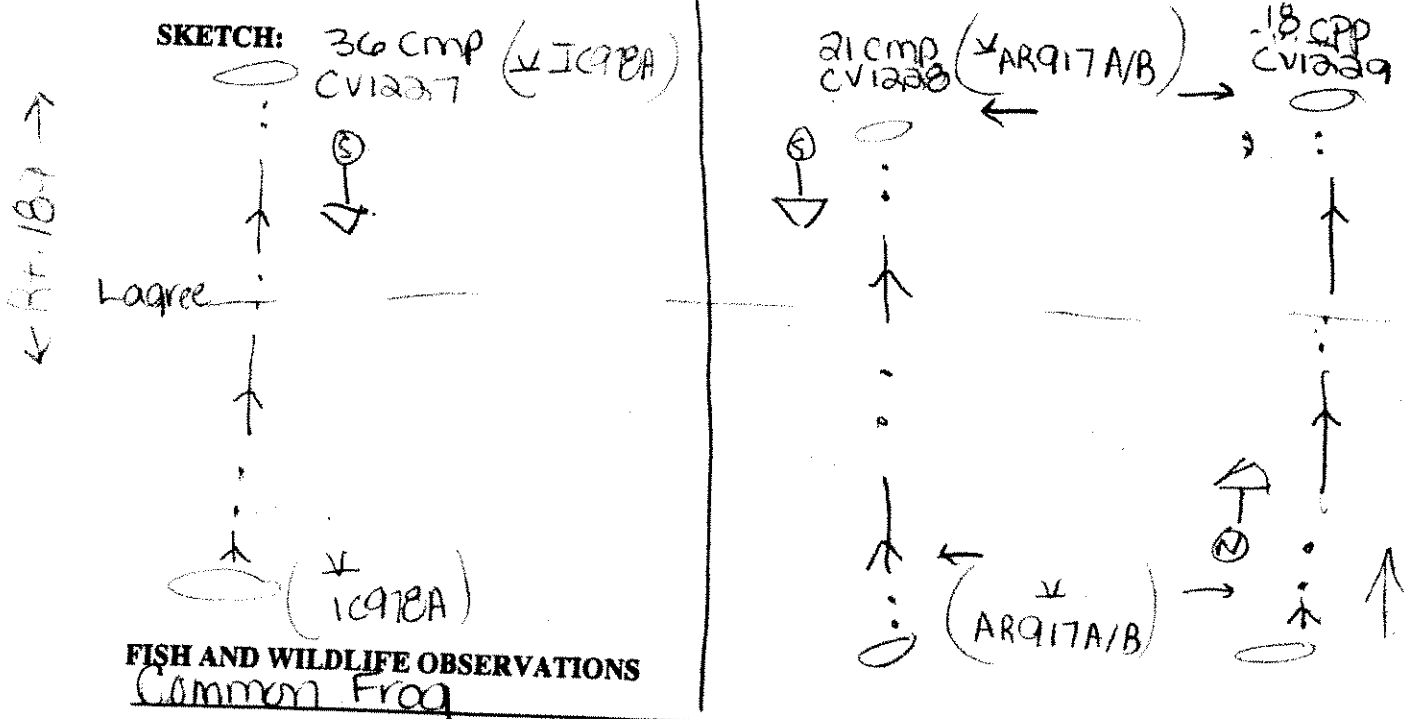
CHANNEL ID	CV1227 A ST	CV1228 A ST	CV1229 A ST
NAME (or trib. to)	NA	NA	NA
TYPE OF STREAM	WL Culvert	WL Culvert	WL Culvert
PEREN/INTERMIT	NA	NA	NA
WIDTH (obser/ohw)	36 / 12-24"	21 / 10-12"	18 / 10-12"
DEPTH (obser/ohw)	NA / 8-12"	4-6 / 10-12"	4-8 / 10-12"
FLOW RATE ¹	Dry	Low	Low
FLOW DIRECTION	North	North	North
SUBSTRATE	NA	NA	NA
BANK VEGETATION	NA	NA	NA

CV1227 36 cmp Culvert connects w/ IC978A/B

21 cmp + 18 cpp Assoc. w/ WL AR917A/B (previously flagged). 18 cpp recently replaced

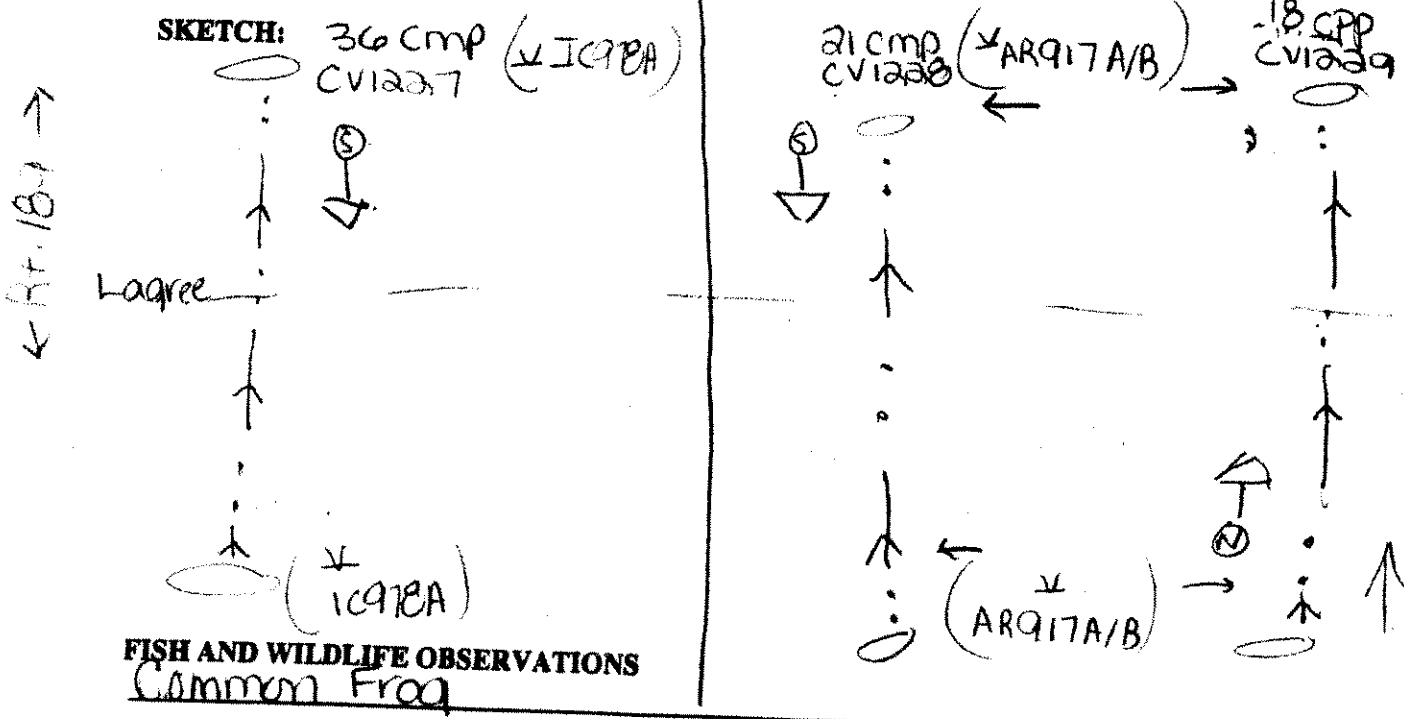
CHANNEL ID	CV1227 A ST	CV1228 A ST	CV1229 A ST
NAME (or trib. to)	NA	NA	NA
TYPE OF STREAM	WL Culvert	WL Culvert	WL Culvert
PEREN/INTERMIT	NA	NA	NA
WIDTH (obser/ohw)	36 / 12-24"	21 / 10-12"	18 / 10-12"
DEPTH (obser/ohw)	NA / 8-12"	4-6 / 10-12"	4-6 / 10-12"
FLOW RATE	Dry	Low	Low
FLOW DIRECTION	North	North	North
SUBSTRATE	NA	NA	NA
BANK VEGETATION	NA	NA	NA

CV1227 36 cmp Culvert connects w/ IC97A/B

21 cmp + 18 cpp Assoc. w/ WL AR917A/B (previously flagged). 18 cpp recently replaced

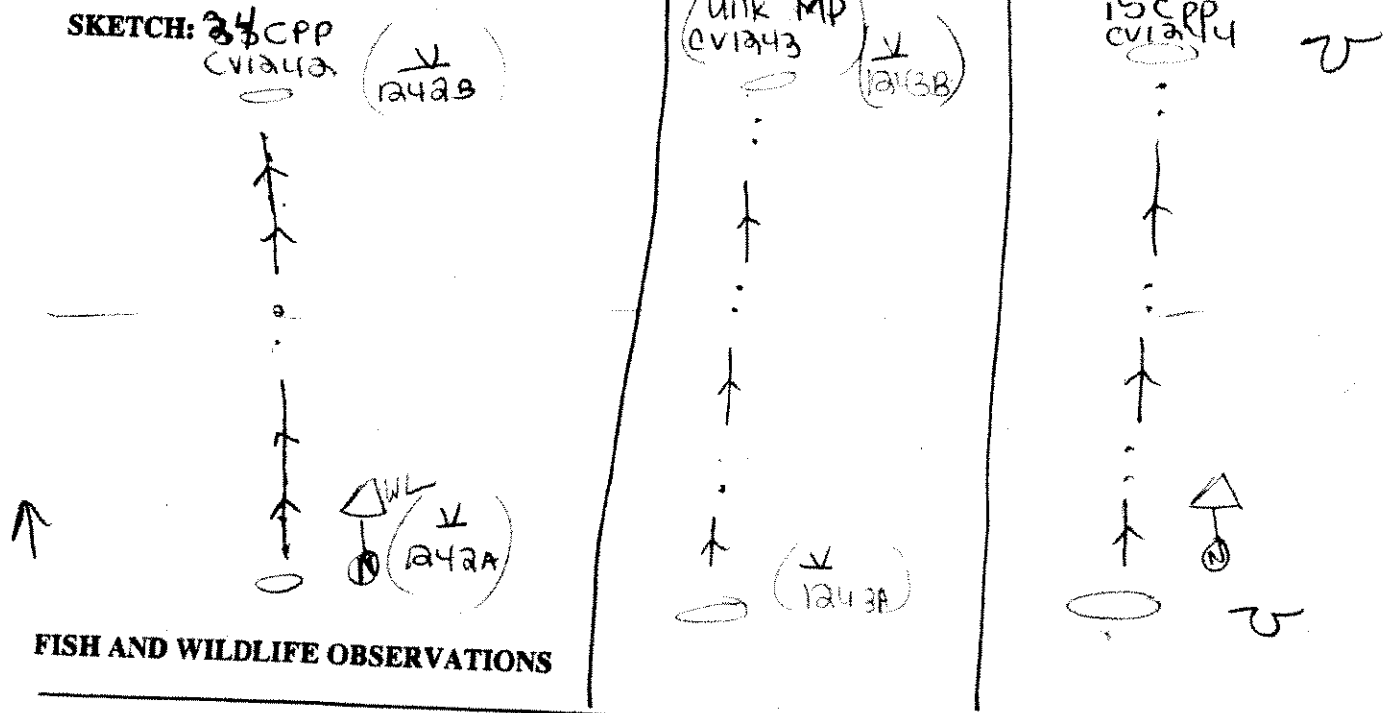
CHANNEL ID	CV1242 ST	CV1243 ST	CV1244
NAME (or trib. to)	UNK	UNK	NA
TYPE OF STREAM	Stream passage	Stream passage	Field drainage
PEREN/INTERMIT	Peren	Peren	Intermit
WIDTH (obser/ohw)	48" / 76"	36" / 48"	15 / 6-10"
DEPTH (obser/ohw)	8-16" / 16-43"	10-12" / 12-29"	NA / 8-10"
FLOW RATE	Med	Med	Dry
FLOW DIRECTION	North	North	North
SUBSTRATE	rock/gravel/silt	rock/gravel/silt	NA
BANK VEGETATION	Herbs/woody	Herbs/woody	NA

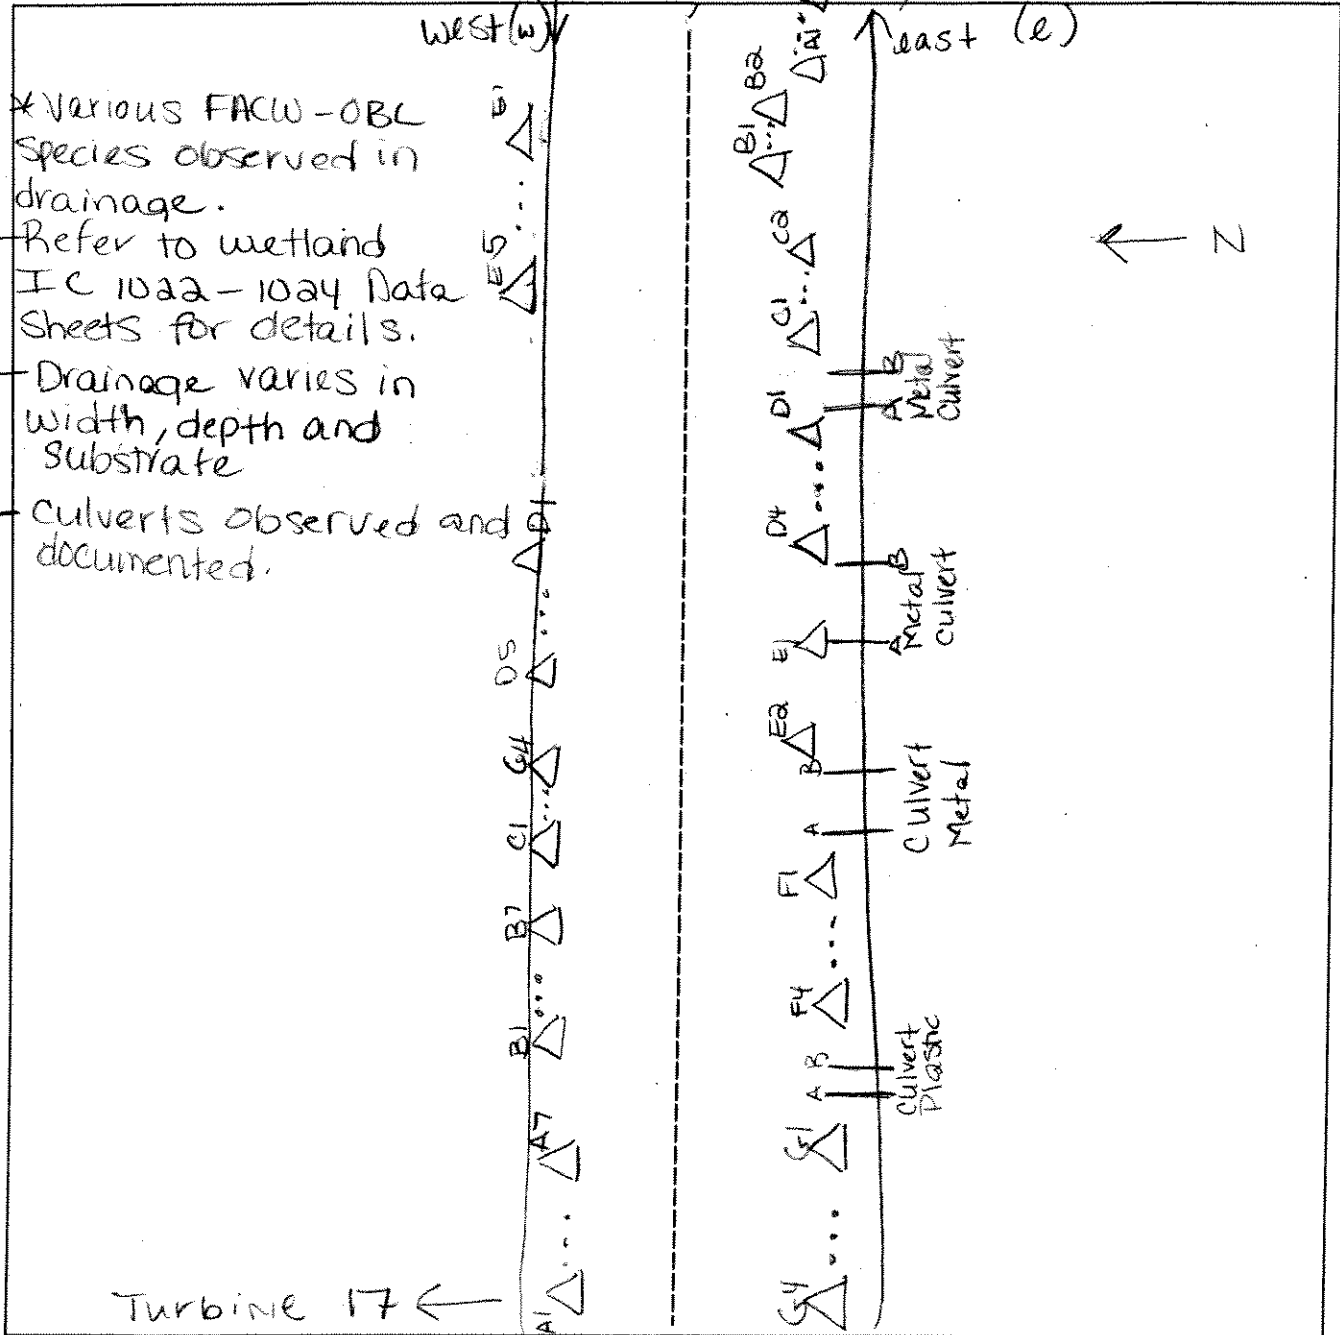
SKETCH FORM

Wetland ID/Route #: RD 3,4,5 e and RD 3,4,5 w	Date: 7-21-06	Time:
Initials of Delineators: JV, BR	Location: Interconnect to turbine 17	
Roll #:	Frames:

- * Various FACW-OBC Species observed in drainage.
- Refer to wetland IC 1022-1024 Data Sheets for details.
- Drainage varies in width, depth and substrate
- Culverts observed and documented.
